Analysis of a seismically induced highway embankment failure during the 2007 Noto earthquake

**P. Kitiyodom, A. Murata, Y. Sasa
E. Shimamoto, T. Matsumoto, M. Kitaura**

**Kanazawa University
Kanazawa, Japan**

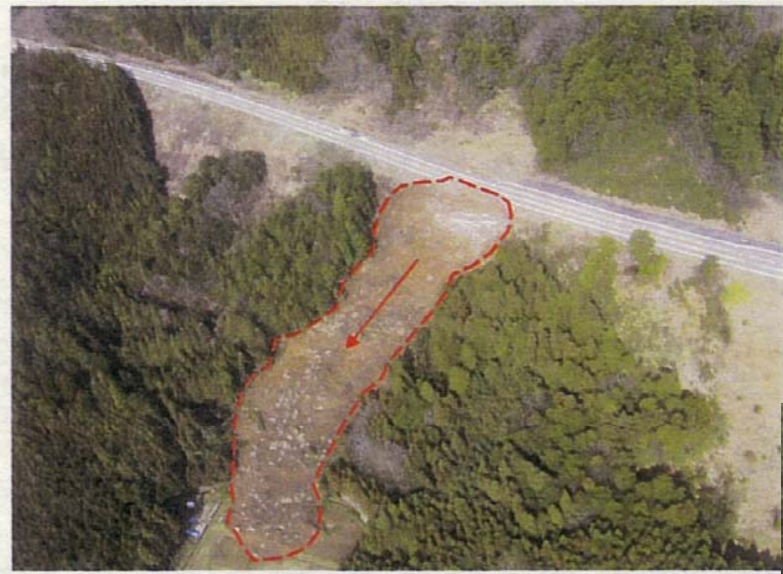
Embankment failure at site T6

Damage (2007.3.25)

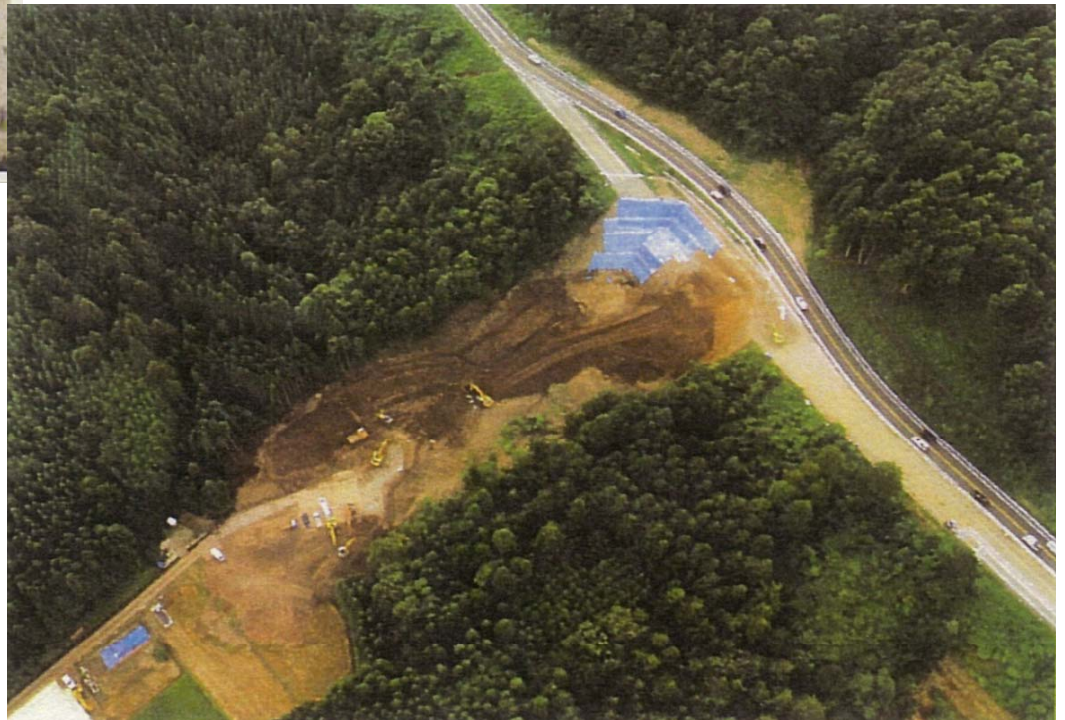
After Emergency Restoration
(2007.8.10)

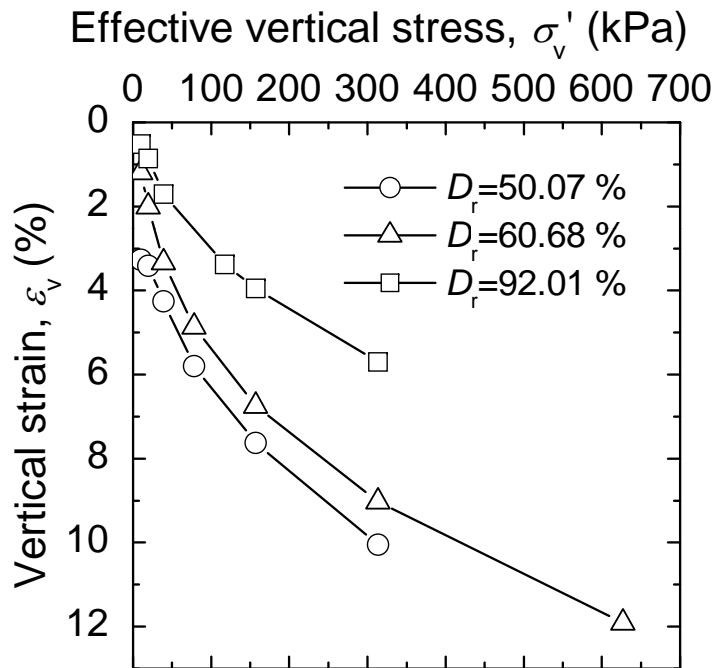
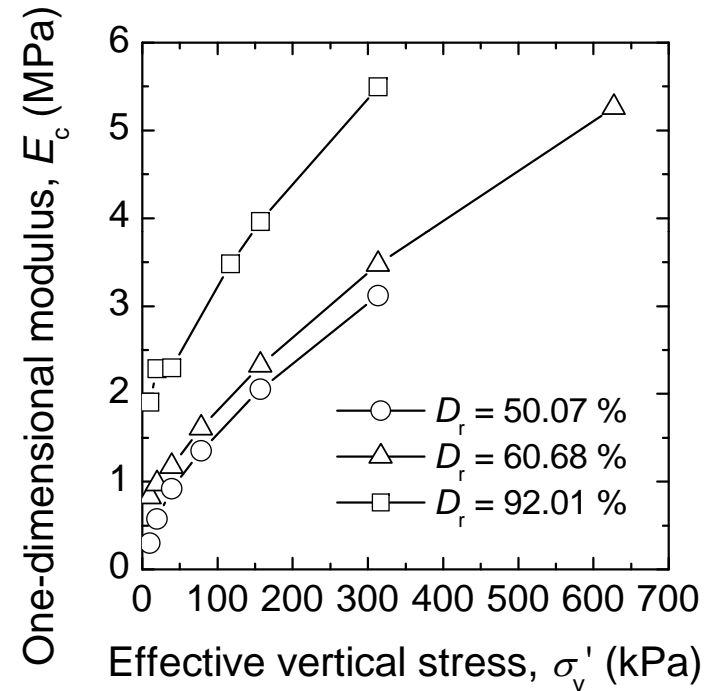
Results of one-dimensional compression tests

Effective vertical stress vs vertical strain

Effective vertical stress vs 1-D modulus

The results of the tests on the dried soil sample with the relative density of 60% were used in the analysis.

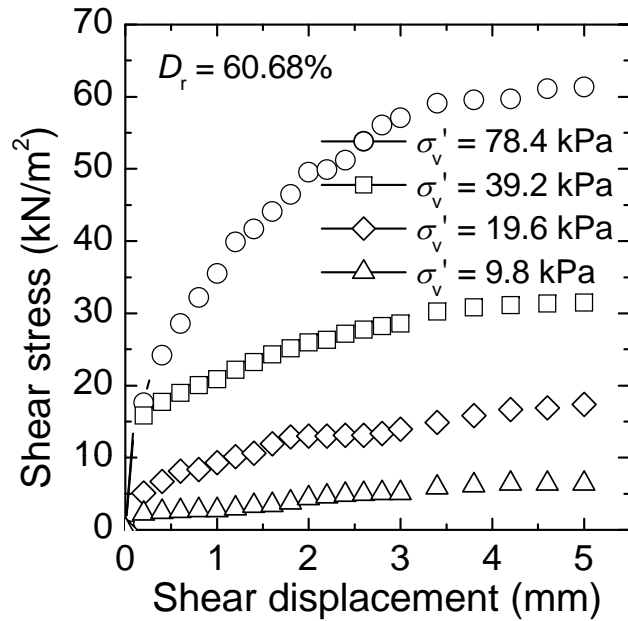
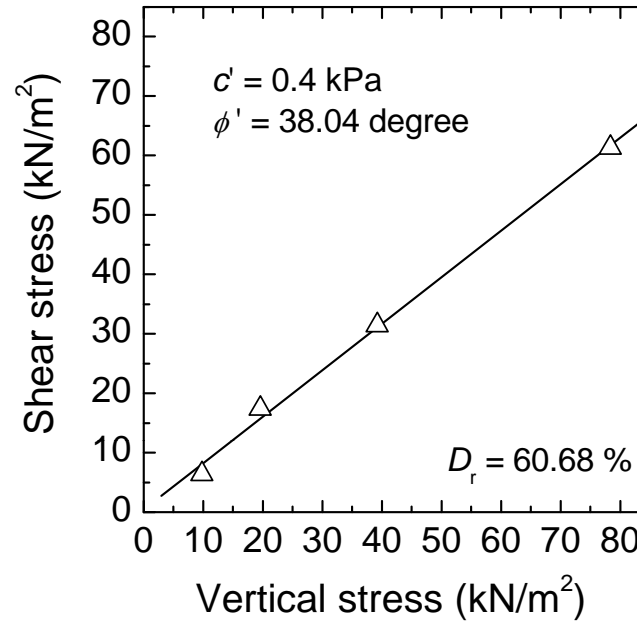
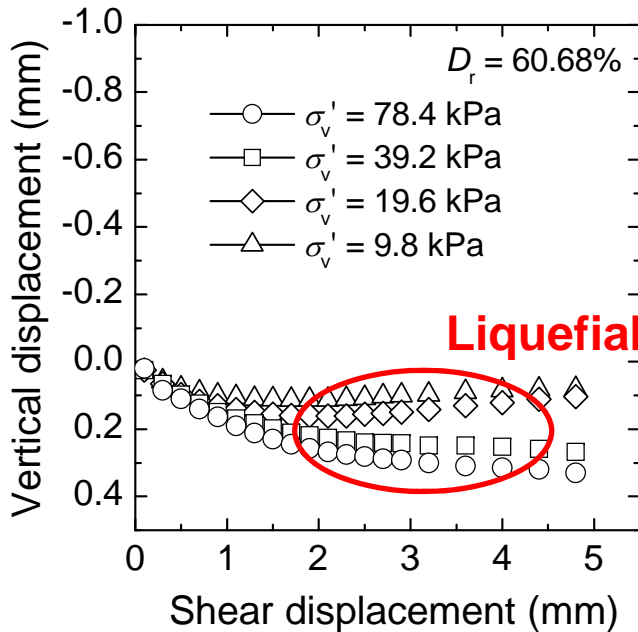
Results of direct shear tests

Ductile material

$c' = 0.4$ kPa

$\phi' = 38.04^\circ$

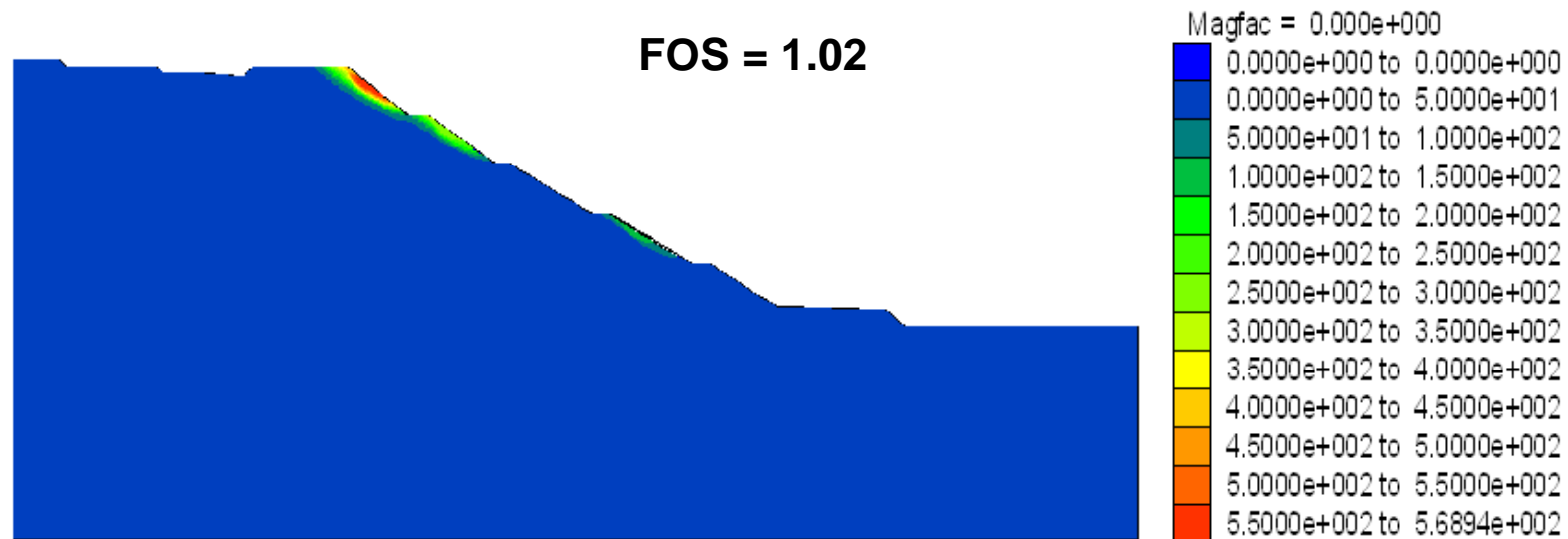
Equivalent static
horizontal acc. = 150 gal

As the reason decided to be 150gal, Again trial and error adjustment of the acceleration was carried out until the safety factor of the embankment is nearly equal to 1.0

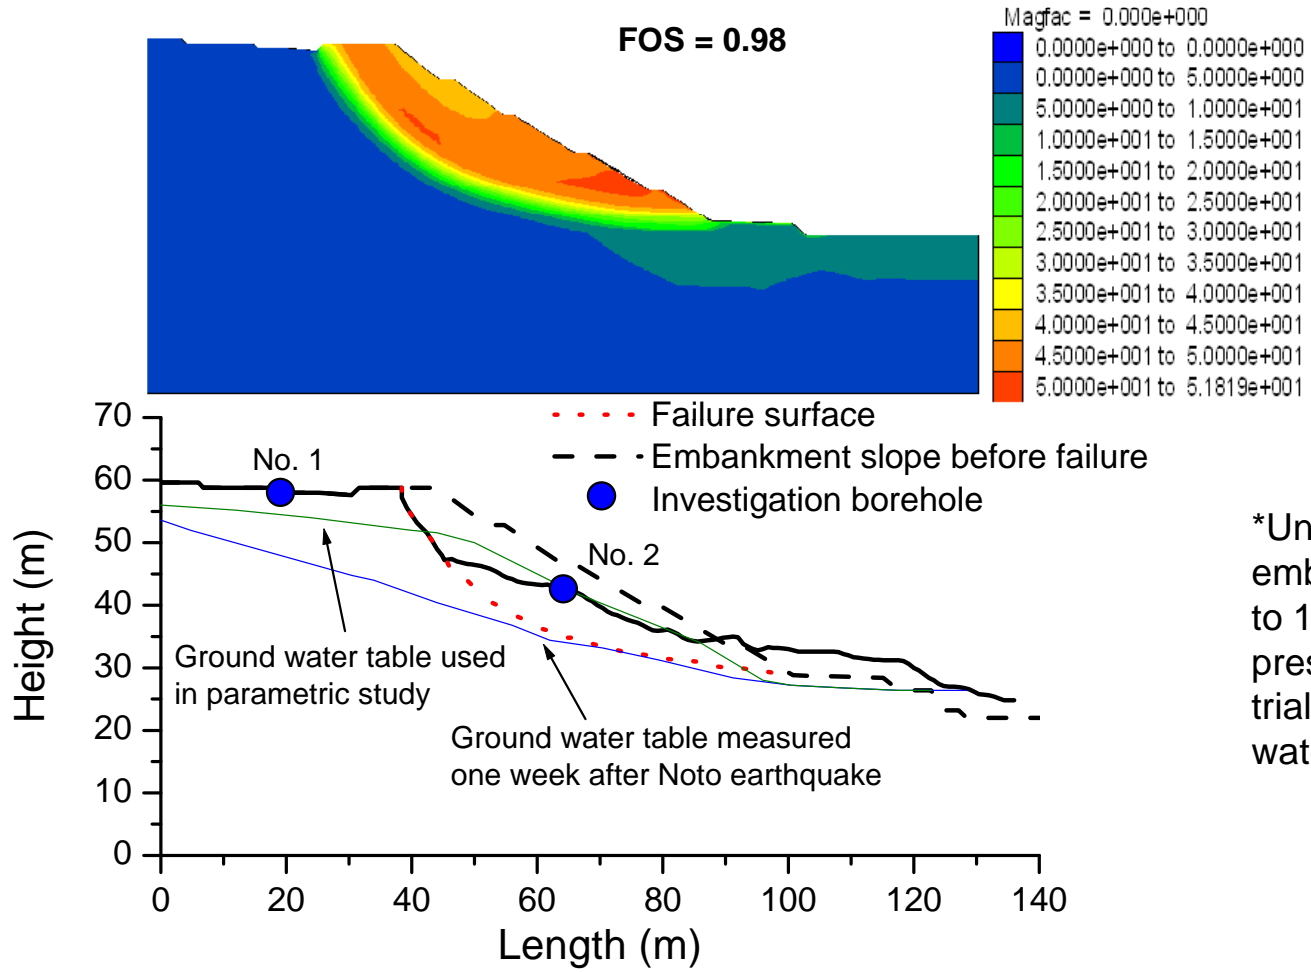
*Until the safety factor of the embankment is nearly equal to 1.0, the effect of pore water pressure was investigated by trial and error adjustment of water table level.

Comparing the calculated resulting failure surface at the site, the failure surface due to the effect of pore water pressure is similar in shape. The excess pore water pressure generated during earthquake is **one of the key influential factors of the embankment failure.**

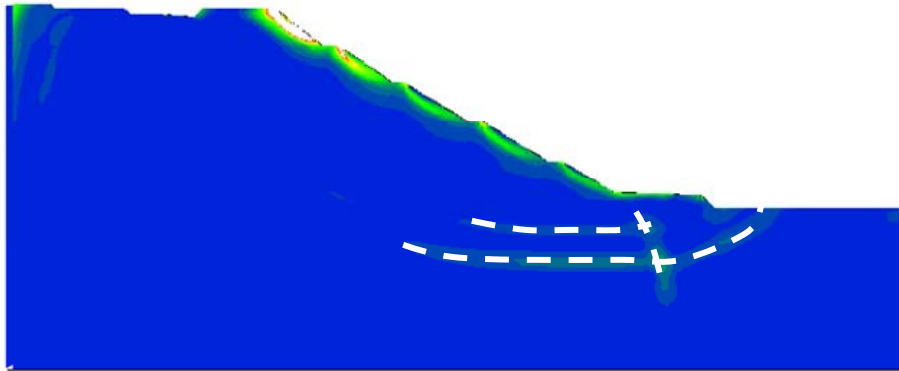
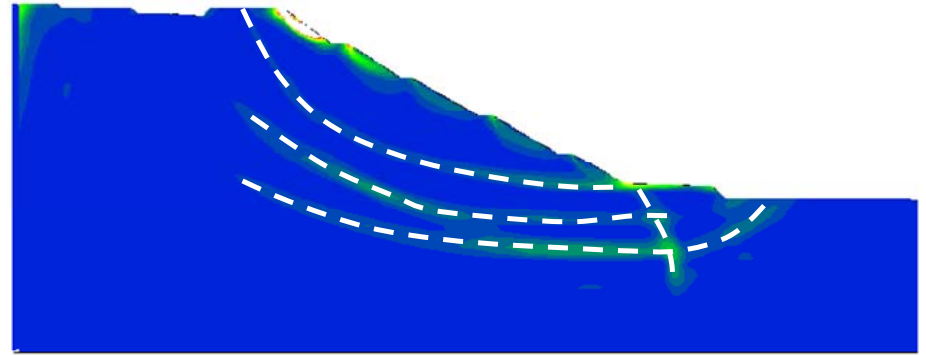
White line is the area of >3% share strain obtained.

Using measured ground water table
($t = 8.5\text{sec}$)

Using higher ground water table
($t = 8.5\text{sec}$)

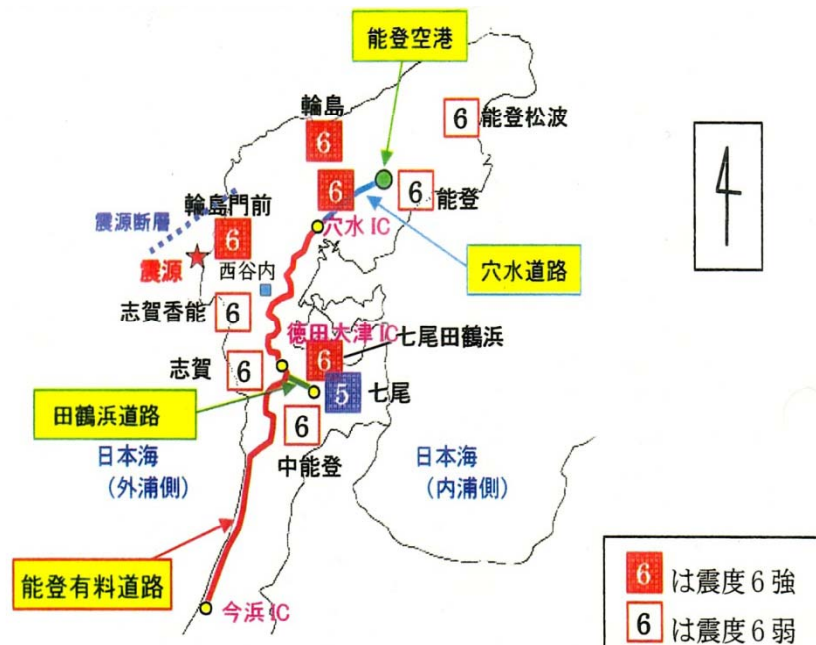
大きな地震動によって、盛土体が強く揺さぶられることにより強度が低下し、安定性を失った。

能登有料道路上り線側（内浦側）の盛土の崩壊が顕著であることから、外浦側から内浦側に向かう強い揺れが引き金であったと想定される。

崩壊に至るメカニズムとしては、沢地形における盛土部の崩壊が多いことから、水分を多く含む盛土が地震動による急激に揺さぶられることにより、盛土内部の水圧が高まり、盛土本体の強度が低下したか、あるいは、盛土下の基礎地盤が地震動による強度低下し、盛土を支えきれずに崩壊に至ったと推察されるが、引き続き調査が必要。

1. 盛土体の靱性を向上させ、壊れにくい道路とするため、ジオテキスタイル等を用いて盛土を行う。
2. 基本的には、崩壊して緩んだ土を再利用して復旧工事を行うため、必要に応じて石灰等を混合して改良し、強度確保と施工性の向上を図る。
3. 盛土の中に水を入れないための地表面の排水対策及び盛土内の含水比を速やかに低下させる排水対策（地山と盛土との境界および盛土内に排水層を設置）に留意した施工を行う。
4. 盛土本体内の間隙水を速やかに排出するための耐圧性ドレーン等を敷設する。
5. 盛土全体の安定を向上させるため、法尻部に崩壊残土による抑え盛土と大型ふとんかご工を施工する。
