Analysis of a seismically induced highway embankment failure during the 2007 Noto earthquake

**P. Kitiyodom, A. Murata, Y. Sasa
E. Shimamoto, T. Matsumoto, M. Kitaura**

**Kanazawa University
Kanazawa, Japan**

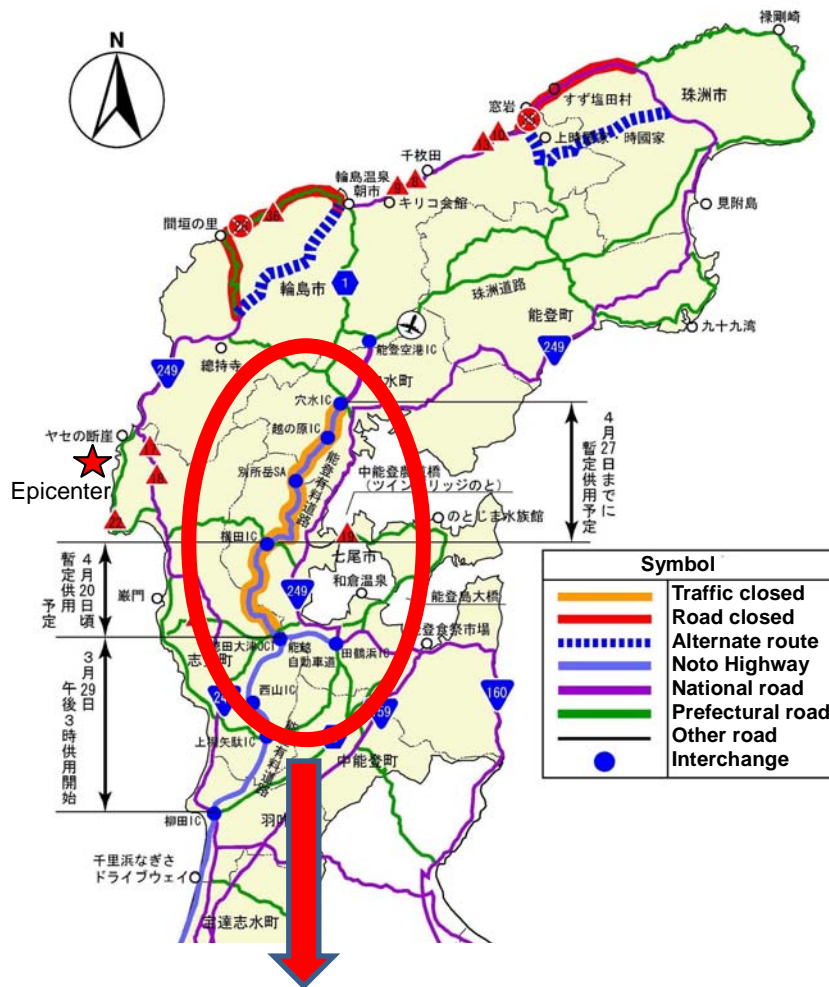
Highway Road Embankments Failures

This highway connects main cities in the Noto Peninsula to Kanazawa city. This highway was an important route for recovery, it needed to be made to restore promptly.

Noto Highway: 11 big embankment failures

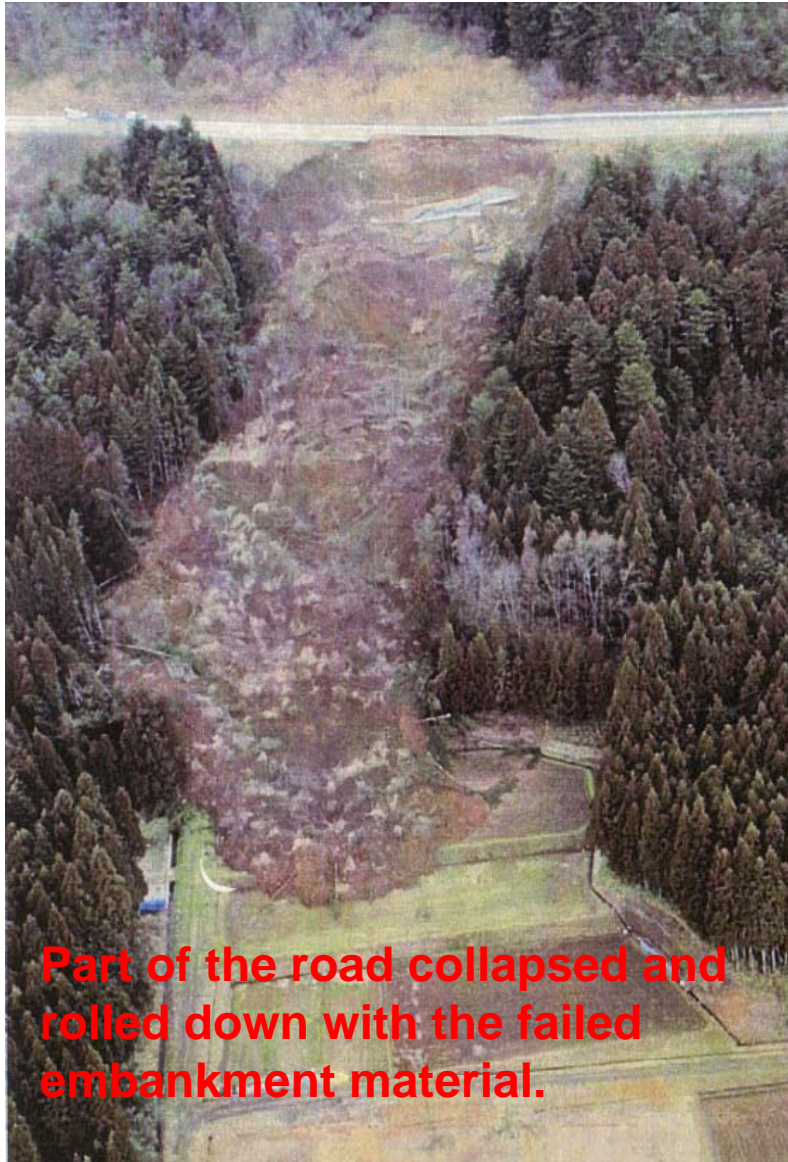
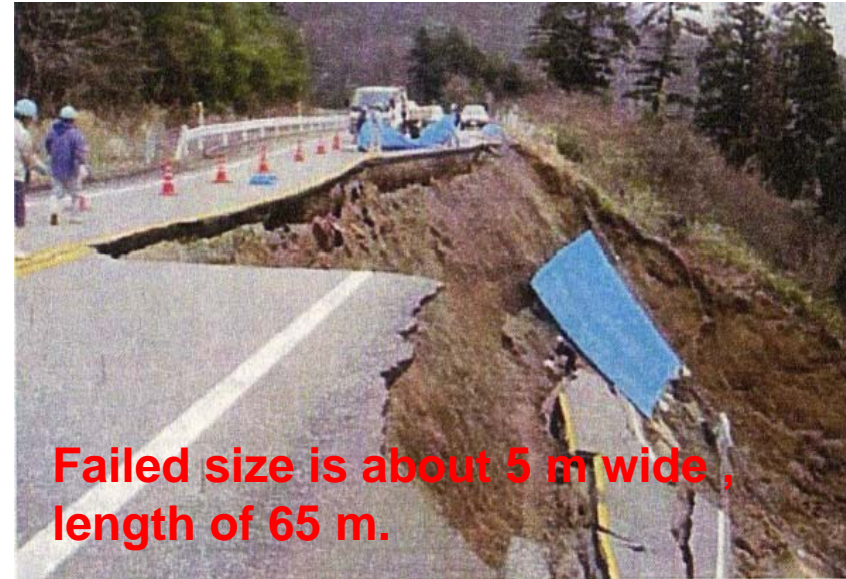
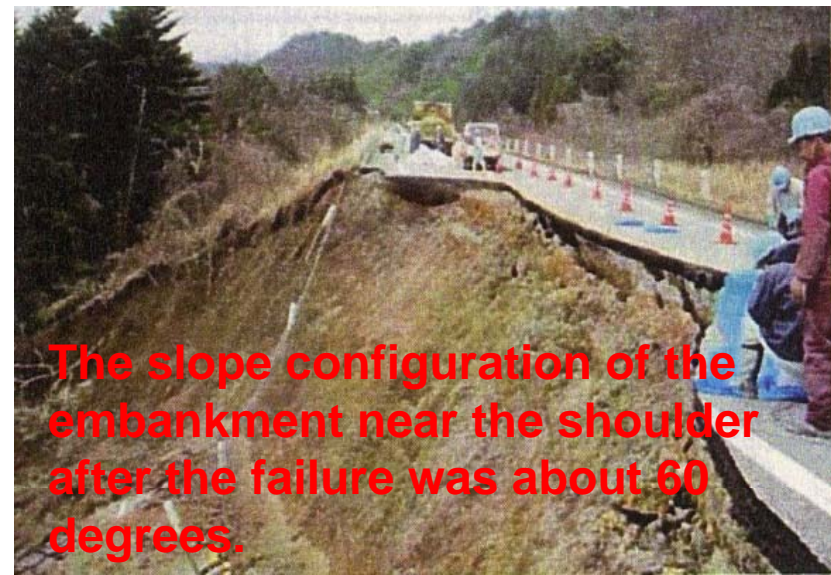
Embankment failure at site T6

Highway Road Embankments Failures

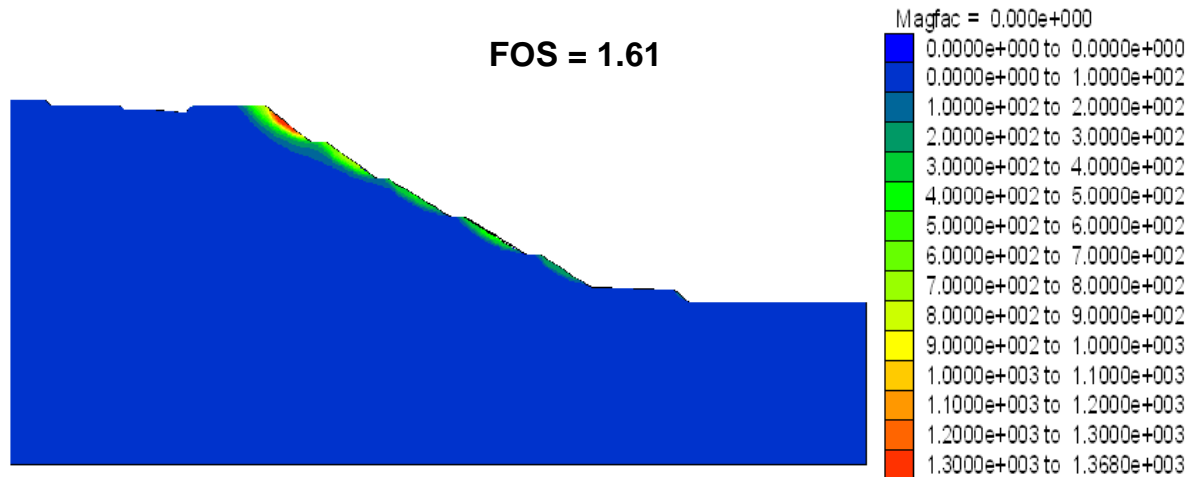
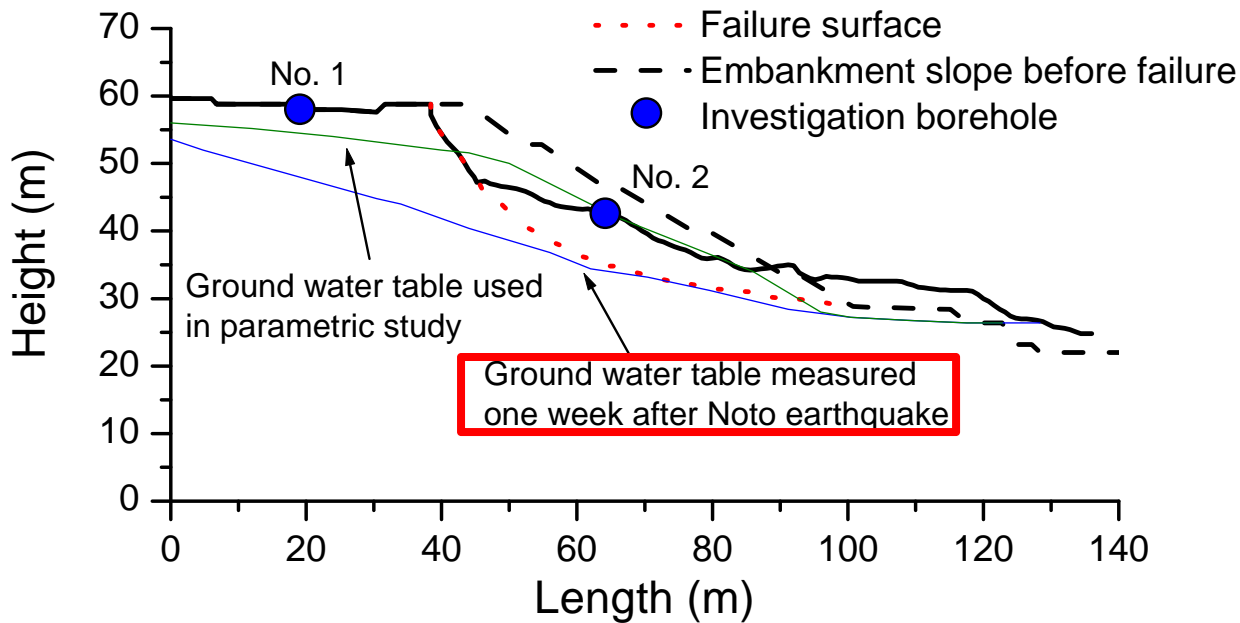
Results –ground water table after failure

Safe?

But...

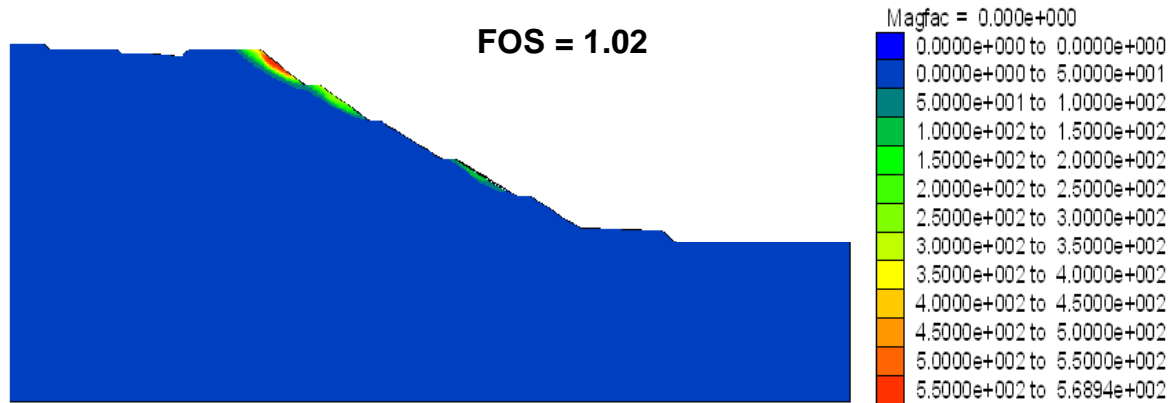
Parametric Study Results (include equivalent static hor. acc.)

Equivalent static
horizontal acc. = 150 gal

The equivalent static horizontal acceleration is **quite small compared with estimated dynamic excitations at the embankment**. This is thought to be due to the kinematic effect of the dynamic problem is not taken into account in the analysis.

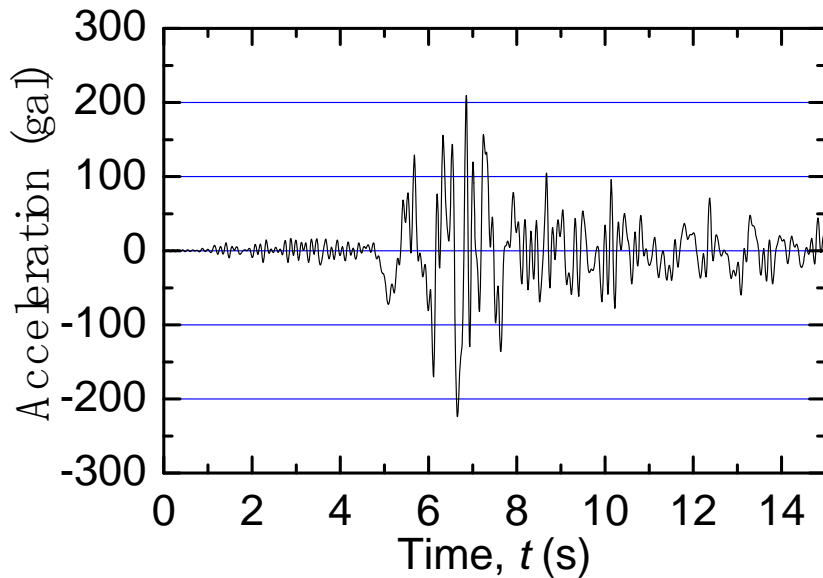
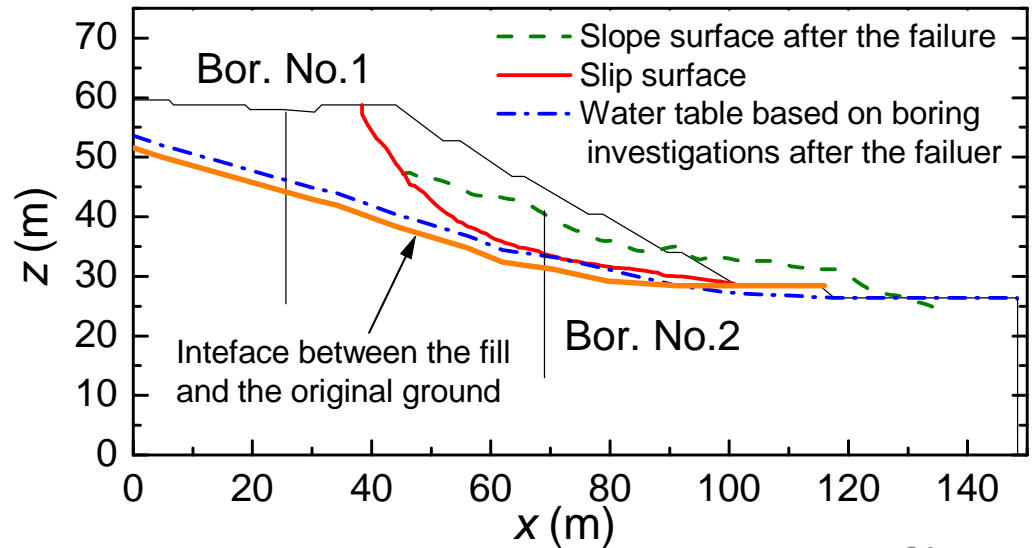
Comparing the calculated resulting failure surface at the site, the failure surface due to the effect of pore water pressure is similar in shape. The excess pore water pressure generated during earthquake is **one of the key influential factors of the embankment failure.**

- There were failures of road embankments in some localities in the earthquake region during the 2007 Noto earthquake.
- The geomechanical parameters were obtained from the laboratory tests of the soil sample collected from the site.
- The excess pore water pressure generated during earthquake is one of the key influential factors in the failure of embankment.
